# UNDERWATER BRIDGE INSPECTION REPORT

STRUCTURE NO. 07569

BLUE EARTH RIVER

MINNESOTA DEPARTMENT OF TRANSPORTATION  
UNDERWATER BRIDGE INSPECTION

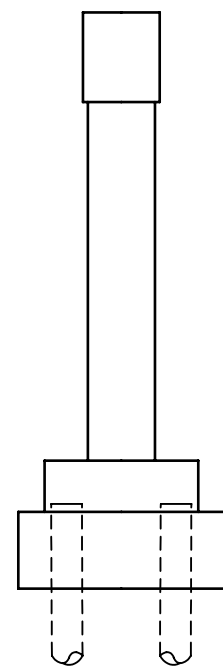
TYPICAL END VIEW OF PIERS

- The channel bottom material around the substructure units consisted of sand, gravel, cobbles, and 1 foot diameter riprap with up to 1 foot of probe rod penetration.
- Heavy accumulation of timber debris, with pieces up to 2 feet in diameter, was observed around the upstream nose and along the west face up to the midpoint of Pier 3. The timber debris consisted of up to 2 foot diameter logs and extended from the channel bottom to 15 feet above the waterline.
- Moderate accumulation of timber debris was observed around the upstream nose and along the west face of Pier 2.
- Scour depression with a 7 foot radius and 1.5 feet of depth was observed around the upstream nose of Pier 2.
- Overall the concrete of the piers was in good condition and only exhibited random vertical hairline cracks.
- Vertical bank erosion was observed all along the river bank.

Reinspect the submerged substructure units at the normal maximum recommended (NBIS) interval of five (5) years.
